Gas Explosion at a Subway Construction Site

Apr. 8th, 1970, Osaka city

KOBAYASHI, Hideo (Tokyo Institute of Technology)

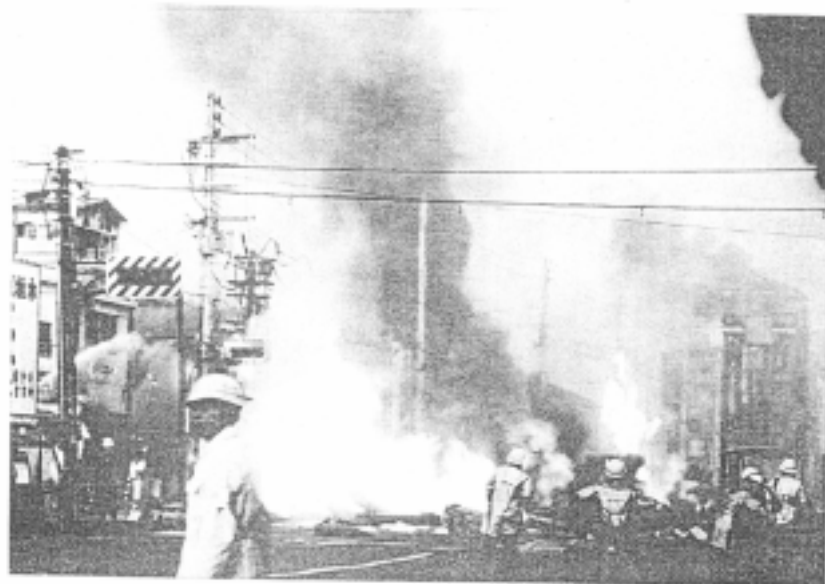
Fig. 2 Appearance of fire by gas explosion.

At about 5:15 pm, 27 workers under suspending work for the exposed pipes escaped from the tunnel to the surface because they noticed the gas that blew out suddenly. At 5:20 pm, a patrol car of the gas company, on the way back to the base by chance, also found the gas leak by chance, and took communications by wireless with an emergency car and a repair car to call out. Fire trucks also arrived by dispatch from stations around the site. At that time, the gas blew out from cracks, 20m in length, between the cover plates. Fire men requested all residents and bystanders in the area to evacuate and avoid using fire. At 5:39 pm, when the emergency car of the gas company started its engine over the cover plates, the car caught fire, and then the gas blowing from the cracks also ignited. The fire gained force gradually, and at 5:47 pm, a huge explosion with a fire pillar of over 10m in height occurred, causing the cover plates to scatter over an area 200m in length. The injured persons and the cover plates fell down to the ground, and the fire pillar expanded to the surrounding houses on both sides.

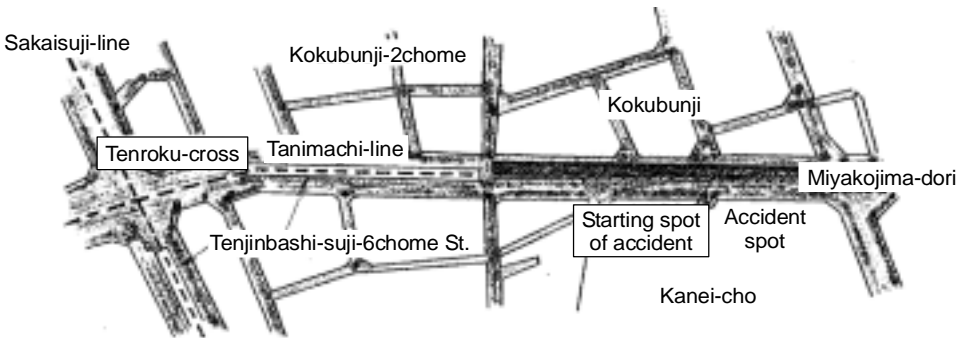
Fig. 3 Rough sketch of accident spot.

The gas pipe, a total of 200 m in length, had two traversing points at both ends forming right angles bends. On the morning of April 8, the soil under the north corner of the traversing point was removed causing the entire length of the medium pressure gas pipe including the traversing points to be suspended, making it easy for pipe to move near the traversing point in a horizontal direction.

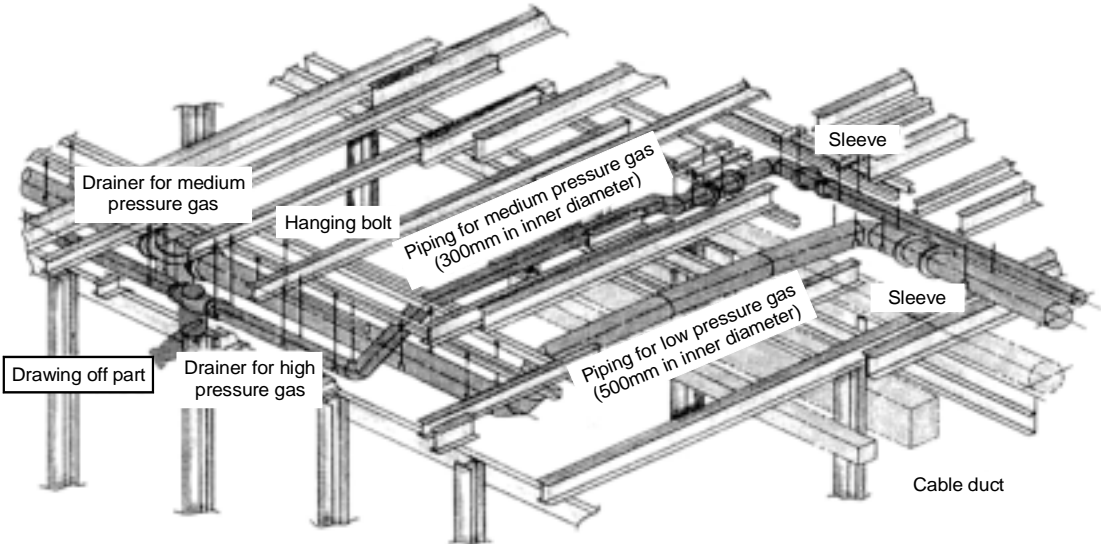
Fig. 4 Appearance of piping for city gas.

At the site of construction for elongation of Osaka city subway line No.2 (Tanimachi line), the suspending work had been conducted in the underground for the exposed pipes of medium and low pressure gas (Figures 4 and 5). A joint of the drainer for the medium pressure pipe became detached, and that caused gas to blow out, ignite, and then explode violently (Figure 6).

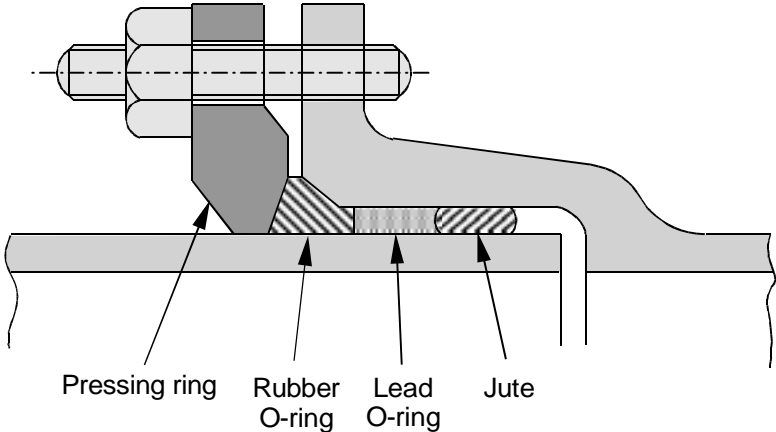
Fig. 6 Connecting method for piping.

The possible causes of the gas leak are considered to be rupture, draw out, crack, or opening of the pipe. Results of investigation after the accident showed that a joint of the drainer for the medium pressure pipe was drawn down, and that was assumed to cause the leak of gas.

The same type of the drawn joint had an initial strength that was rated against an inner pressure of about 8 tons, however, the detached joint could not resist an inner pressure of even 1 ton. The cause of this change in the strength of the joint could be one or more of the following; (1) the strength of the joint had decreased, (2) no measure was taken to prevent the drawing off the joints, and (3) the construction work on the day of the accident formed a suspending condition of the pipe. These complex conditions caused the drawing down of the joint of the pipe.

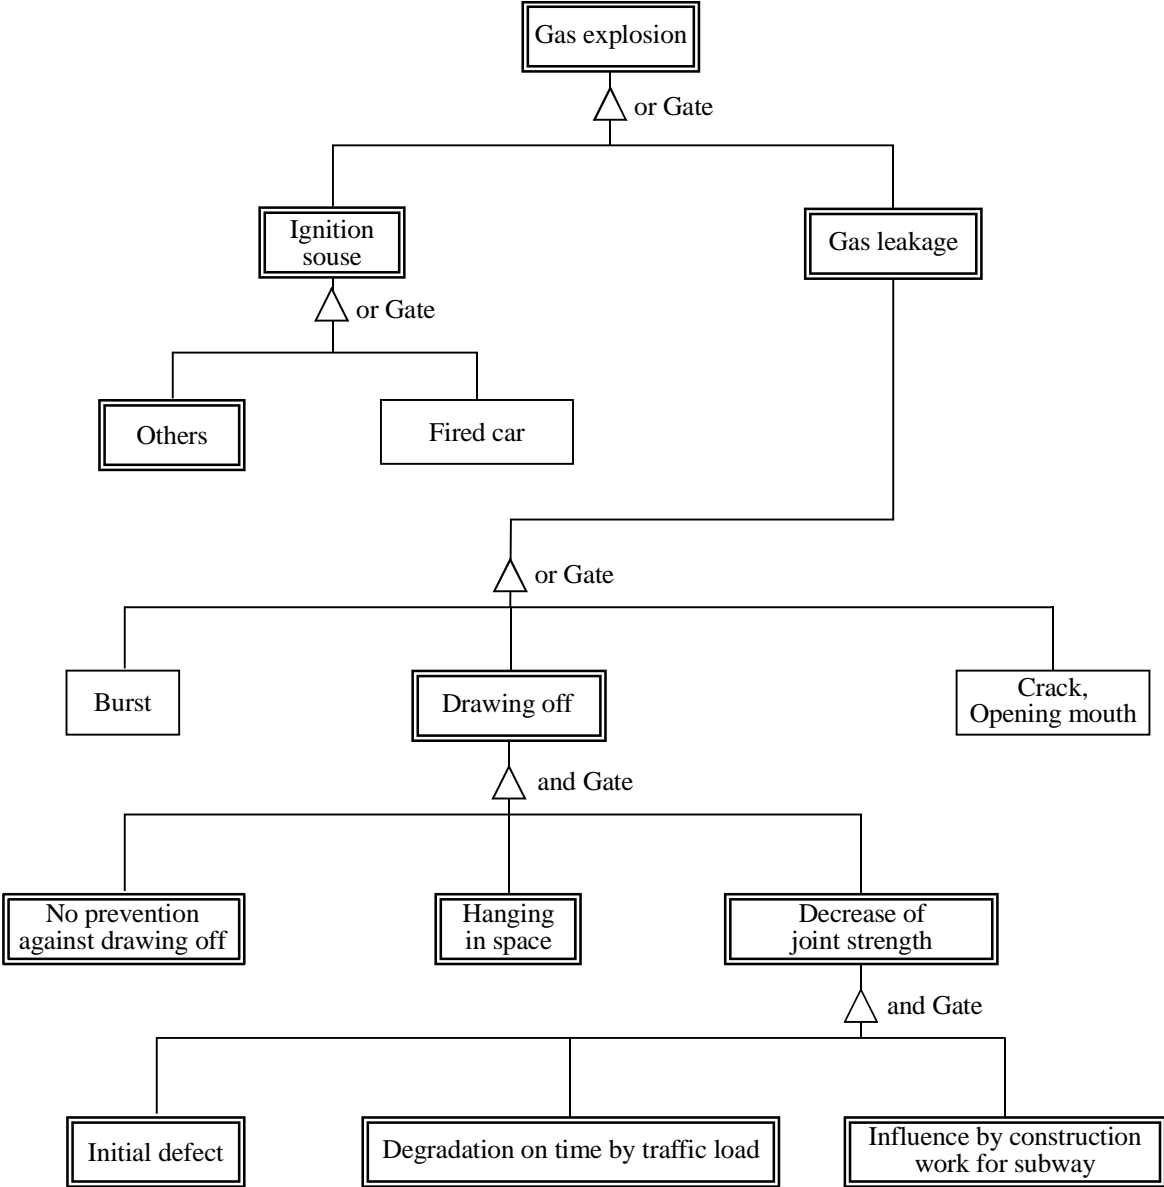
Fig. 7 Fault tree diagram based on morphology, mechanism, and process of the destruction.

Cause (1) of the decrease in strength of the joint was considered to be the result of the following three factors, initial defects, gradual degradation over time by the traffic load, and influences from the construction work of the subway. The possibility of initial defects that were formed when the joint buried

under the ground, was estimated by considering the working situation and procedure of the burying process as well as the burying conditions at that time. The gradual degradation of the joint strength was considered to be important because of the shallow depth at which the medium pressure gas pipe was buried that caused it to suffer from vibration and subsidence by the passing traffic vehicles prior to the start of the construction work on the subway. After beginning the subway construction work, repeated excavation and burying in the area for the experimental drilling and covering was estimated to exert a larger influence than the traffic loads even though the period was much shorter.

The source of the ignition was regarded at first to be an emergency vehicle, which caught fire at the site of the gas leakage. However, because the fire of the emergency vehicle continued for about ten minutes, the concentration of the gas mixture in the upper part of the pit just below the fire was believed to have already exceeded the limit of combustion, so that there was no fear of catching fire. Otherwise, the fire in the emergency vehicle should have occurred at the same time as the ignition of the explosion. The explosion occurred at near the center where the emergency vehicle that had caught fire located. However, the ignition point does not always coincide with the center of explosion because of a phenomenon by which the flame caused by the ignition propagates in the mixed gas before the explosion. From the reasons mentioned above, it is difficult to consider that the emergency vehicle fire was the source of ignition. There were many other potential sources of ignition around the site. The ignition source was considered to be one of those other potential sources except the emergency vehicle.

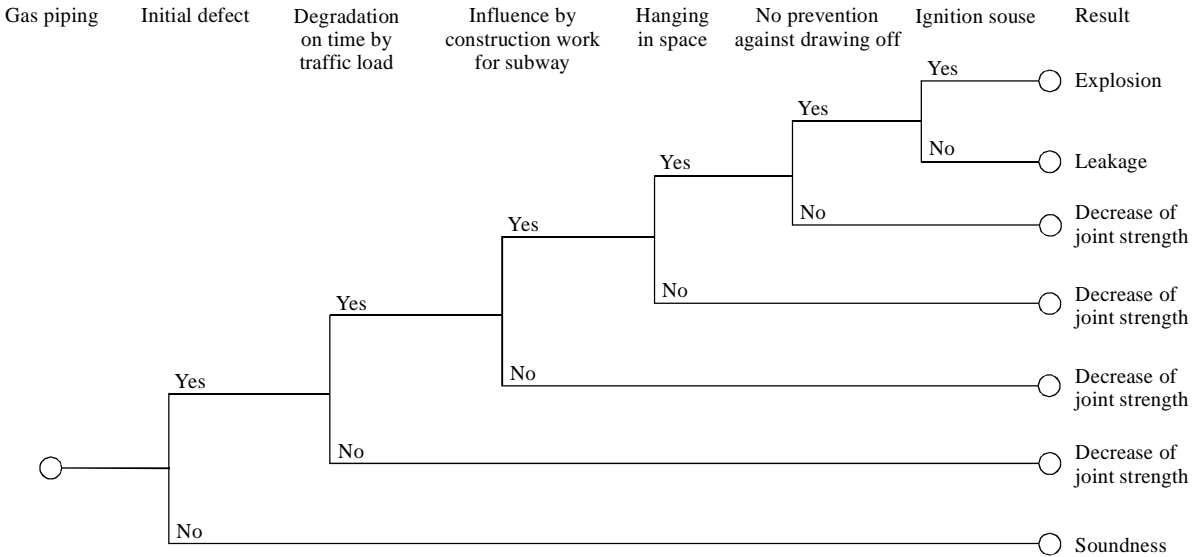
Fig. 8 Event tree diagram for the explosion and the leak of gas by drawing off the joint.

The fastening strength of the gas pipe was decreased by an initial defect that had occurred immediately after the burying work. Furthermore, the joint strength degraded gradually over time from vibration and subsidence caused by the traffic loads, and finally the joint strength decreased rapidly as a result of the influences of the subway construction work. The pipe was exposed in hanging condition during the construction work. The decreased joint strength could not resist the inner pressure because there was no prevention against drawing off. Then the joint was drawn off, and caused the gas leak. The explosion occurred as a result of some unidentified ignition source.
